DEGRADATION OF COATING ALLOYS  
IN SIMULATED MARINE ENVIRONMENTS

R.H. Barkalow and F.S. Pettit  
Pratt & Whitney Aircraft Division  
United Technologies Corporation  
400 Main Street  
East Hartford, Connecticut 06108

15 June 1978

Final Report: 1 March 1976 to 1 March 1978

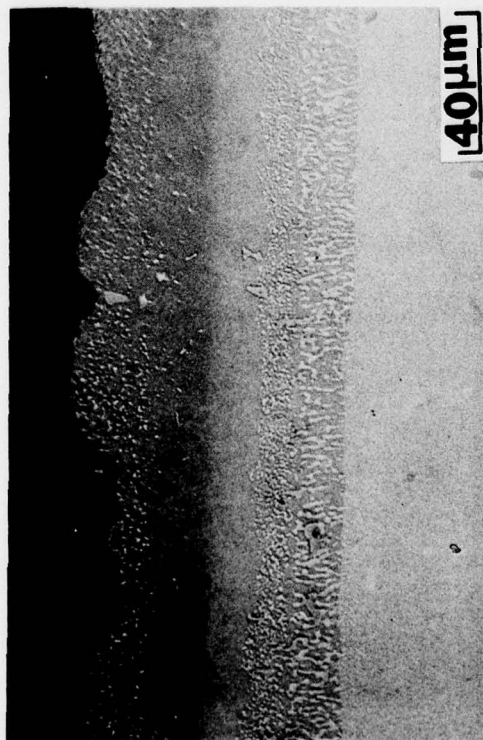
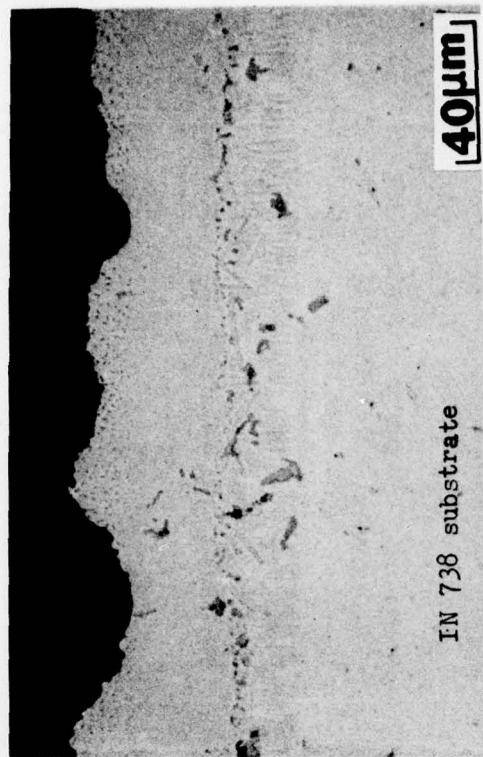
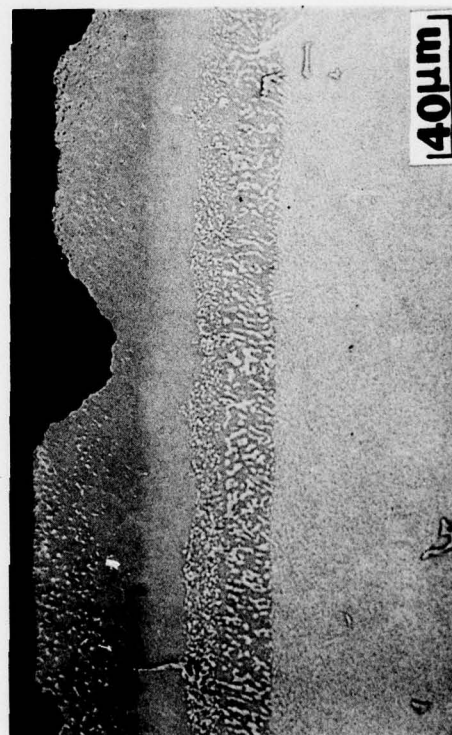
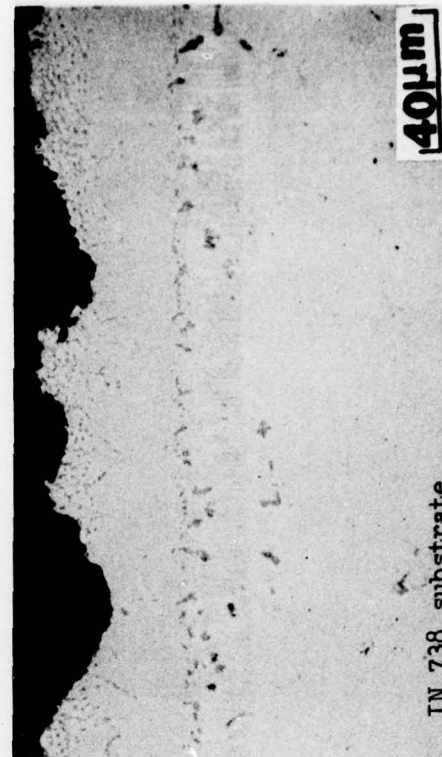
No significant difference in performance of four specimens of diffusion aluminide coatings (PWA 273, PWA 70 + PWA 273, PWA 73, and Ti + PWA 273) on IN738 was discernable, except possibly for a thicker oxide and greater scale spallation on the Ti-modified coating. Post-test metallography showed a similar nature and extent of attack on all of the samples (Figure 70).

Figure 70. Degradation of Ni-base diffusion aluminide coatings in 649°C hot corrosion test with  $\text{Na}_2\text{SO}_4$  salt and  $\text{SO}_3$  gas. Exposure time = 100 hours (5 cycles with fresh salt applied every 20 hours).

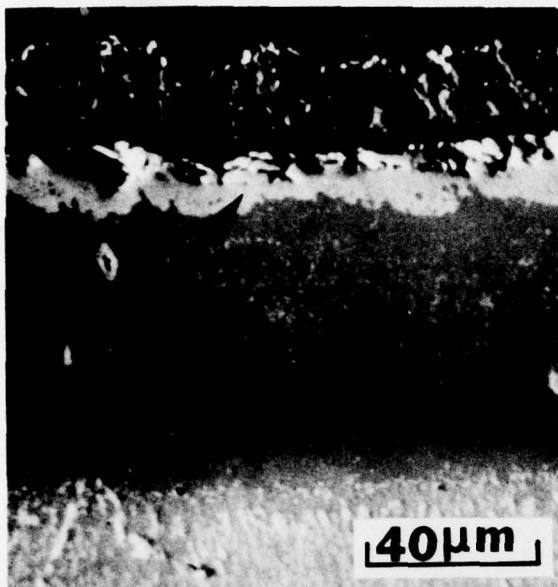
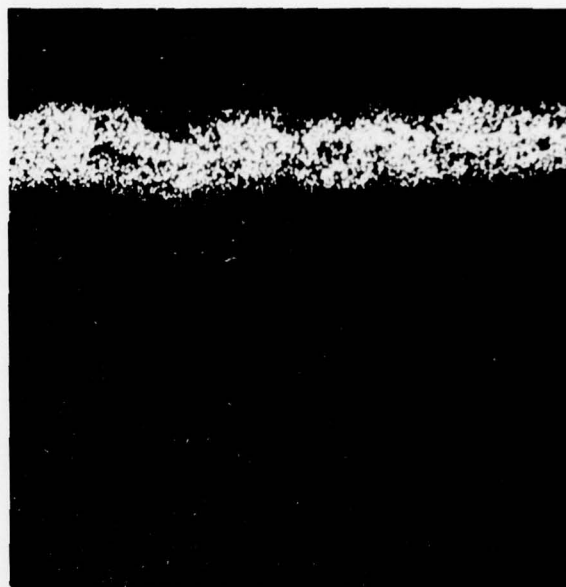
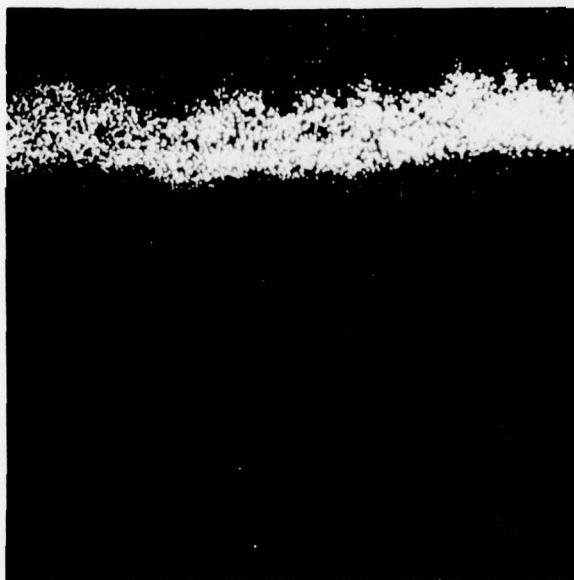
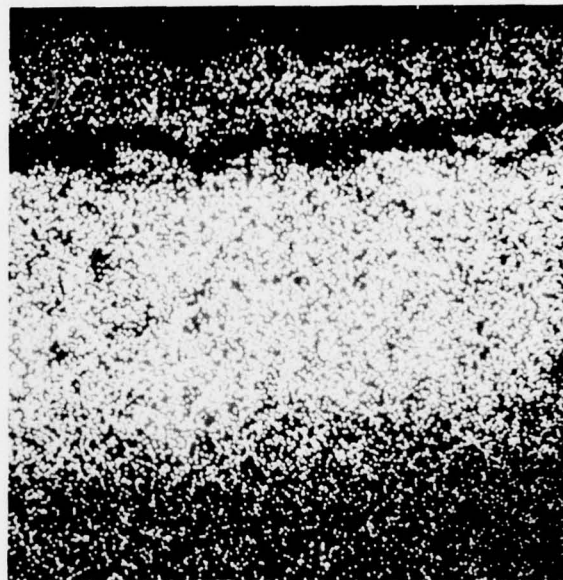
Somewhat surprisingly in view of the ineffectiveness of the Pt overlayer on CoCrAlY, the Pt-modified PWA 273 appeared distinctly better than the other aluminides. The initial visual inspection at 20 hours suggested relatively little degradation, although there was some evidence of selective attack after 100 hours. Metallographic examination showed a Pt-rich surface layer generally unaffected except for a thin scale (Figure 71).

Figure 71. SEM photomicrographs of sputtered platinum + PWA 273 diffusion aluminide coating tested concurrently with the specimens of Fig. 70. Residual salt and surface scale are evident on the dry-polished sample, but a Pt-rich surface layer (arrow) is still intact and there is minimal dealloying of the  $\beta$ -NiAl.

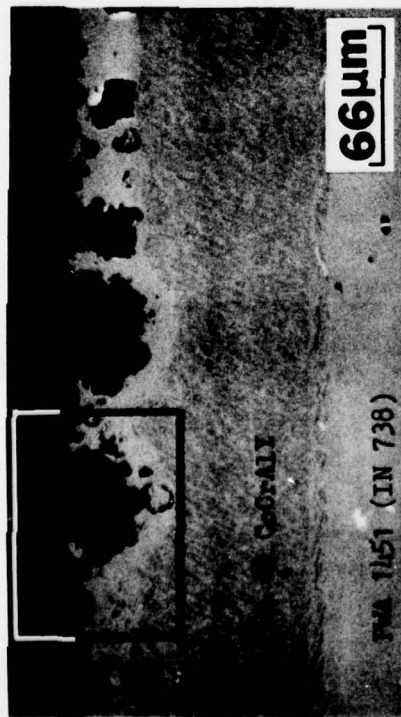
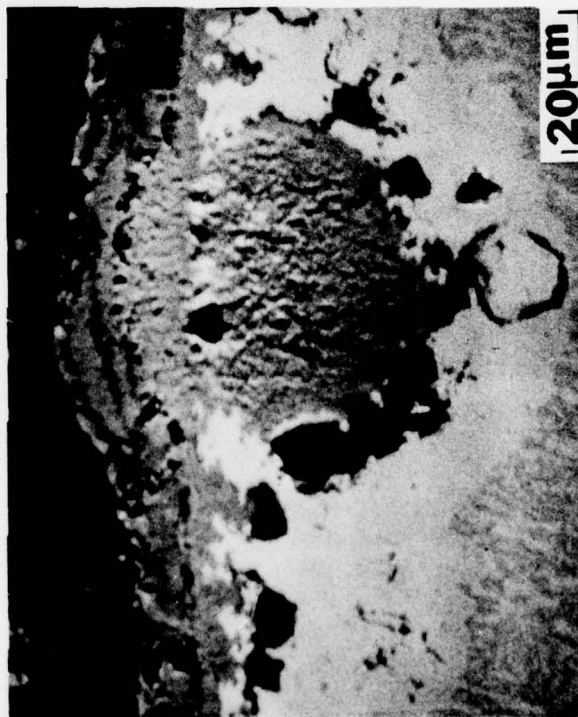
72a. PWA 68 CoCrAlY coating

Post-test metallography of the PWA 68 coating showed corrosive attack of the depth and morphological form illustrated in Figure 72a. Although the extent of corrosion is substantial, the shape of the nodules and extensive  $\beta$ -depleted zone do not resemble the features observed in the service hardware examined for this program.

Figure 72. Hot corrosion of CoCrAlY-coated In 738 and bulk PVD Co-25Cr-6Al in 899°C (1650°F) test with  $\text{Na}_2\text{SO}_4$  salt and  $\text{SO}_3$  in the gaseous environment. Exposure time = 100 hours.

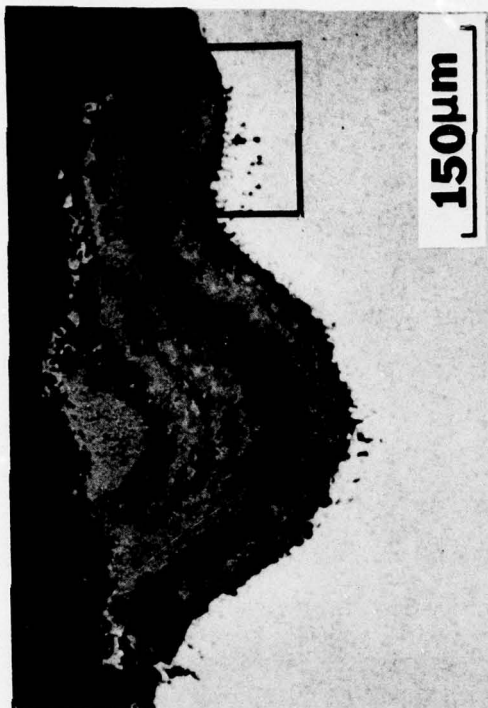
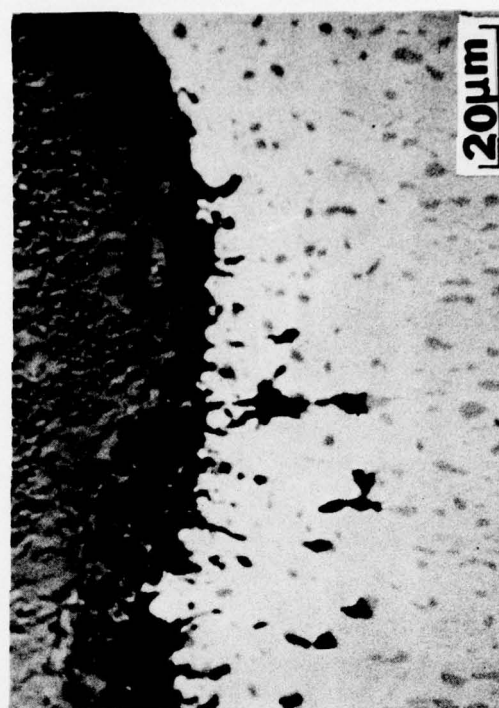
72b. PVD Co-25Cr-6Al

The Co-25Cr-6Al showed several areas of very deep, localized attack as in Figure 72b. Again there was a substantial  $\beta$ -depleted zone with precipitates of Cr-rich sulfides (black arrows); a layer of corrosion product immediately adjacent to the scale/metal interface was highly enriched in aluminum and sulfur (area scans not presented).

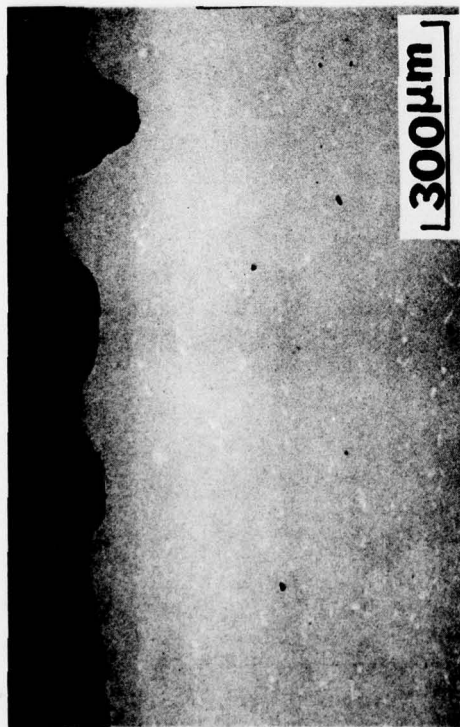
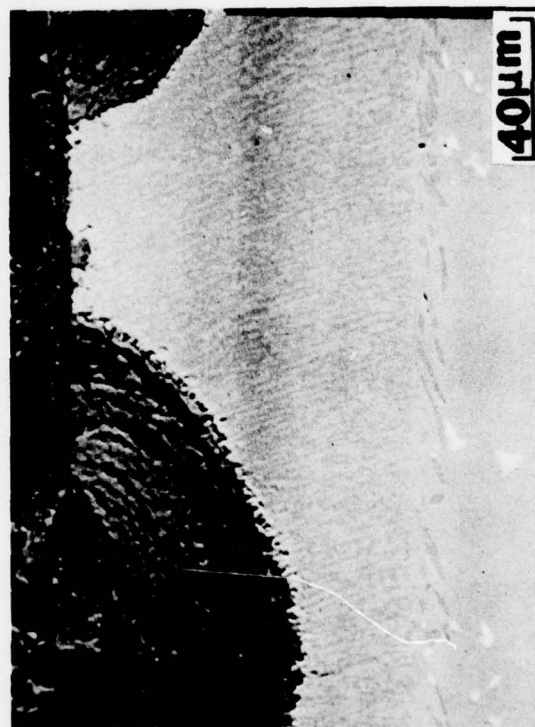
a. Typical protrusions and structure of scale/  
metal interface

Figure 73. CoCrAlY-coated IN 738 exposed 40 hours at 760°C (1400°F) with  $\text{Na}_2\text{SO}_4$  salt and  $\text{SO}_3$  in the gaseous environment. Coating was penetrated in numerous areas and completely consumed on one edge of the coupon.

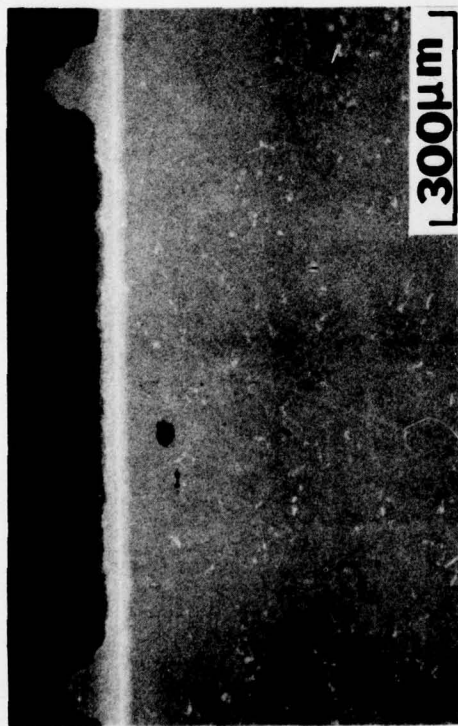
Lastly, two specimens of FWA 68-coated IN738, one with a platinum underlayer, were tested at 760°C (1400°F); the equilibrated  $\text{SO}_3$  pressure at this temperature is about 0.02 atm. Visual observations indicated the attack was more severe than at 649 or 899°C, and the test was terminated after 40 hours. Metallographic examination confirmed the extensive hot corrosion of both specimens. The FWA 68 coating was penetrated in numerous areas of highly localized attack, and the coating on one edge of the specimen was completely consumed (Figure 73). General surface degradation and material consumption was even more extensive on the specimen with the platinum underlayer, and two sites of penetration into the substrate were observed on the plane of polish being examined. However, there was a striking tendency for the attack front to stop at the platinum-containing diffusion zone, even on the curved edge which is almost always the initial site of localized coating failure (Figure 74).

a. Typical protrusions and structure of scale/  
metal interface

Figure 74. Pt underlayer + PWA 68 CoCrAlY tested concurrently with the specimen of Fig. 73. General surface degradation was equally extensive, but attack front tends to stop at Pt-containing zone.

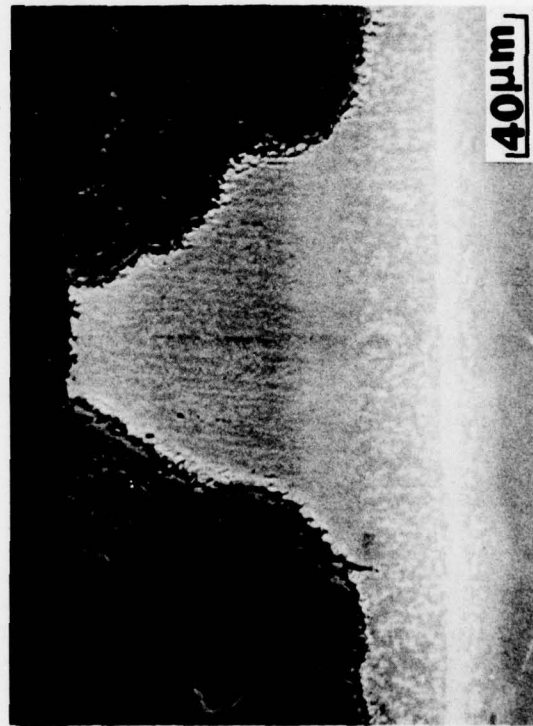
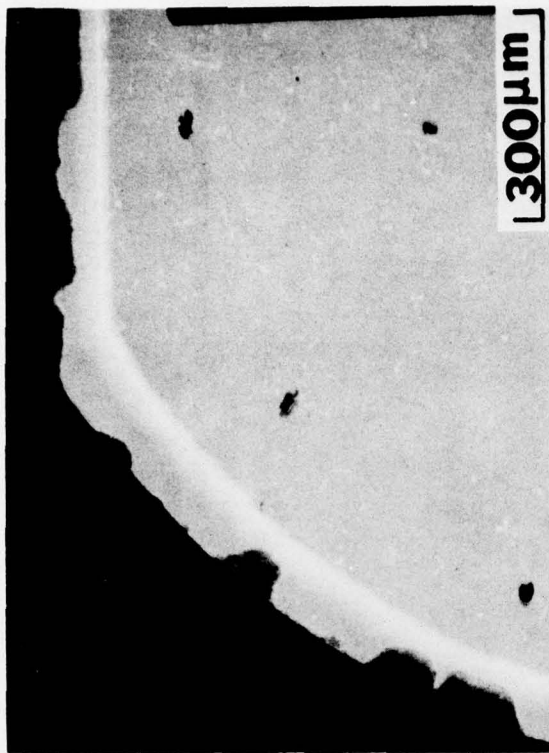
b. Coating at edge is still intact
